Introduction

To study layer-wise rutting of a flexible pavement using a multi-depth deflectometer and compare the strain developed in subgrade with a linear elastic software.

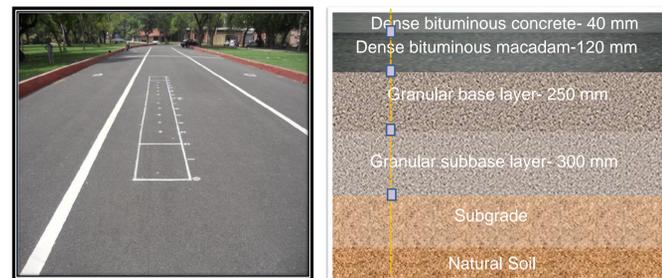
Figure 2: Crust composition of pavement

The pavement was designed for 30 Million Standard Axle (MSA) traffic and 5% CBR.

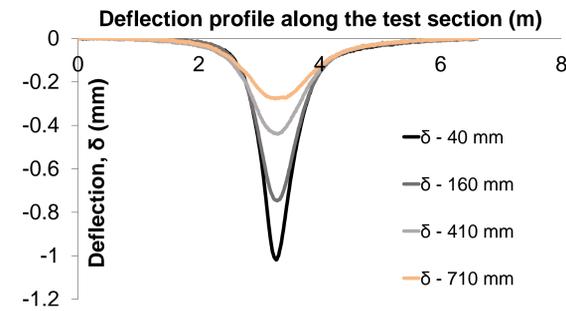
Figure 3: Typical deflection at the interface of pavement layer

- The deflections were measured using a Multi-Depth Deflectometer (MDD) at the interface of each layer.
- The deflection observed using MDD under loading at 40 mm is the sum of the deflection of all layers.
